# Case involving hydrogen cyanide poisoning during research work

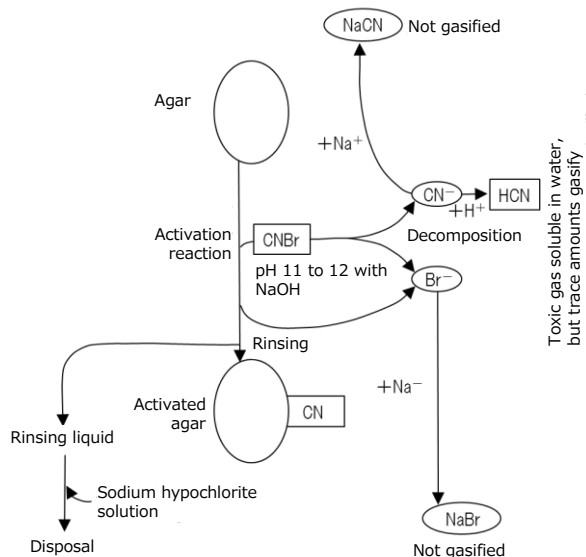
(a) Outline of adsorbent preparation

In a post-treatment process following the preparation of an adsorbent, hydrogen cyanide was generated by a chemical reaction in which sodium hypochlorite was added to treat the water from which cyanobromide had been removed.

No measures were in place to prevent exposure. The worker was exposed to hydrogen cyanide.

[4] All research staff must undergo health and safety training based on the results of reviews of the health and safety aspects of all work carried out within the research laboratory.

We recommend deploying gas monitoring systems and implementing measures to minimize the risks associated with working in environments in which gas may be generated, as highlighted in risk assessments.
