Case involving hospitalization due to chlorine gas poisoning and chemical conjunctivitis after waste liquid was poured into a waste liquid tank containing water

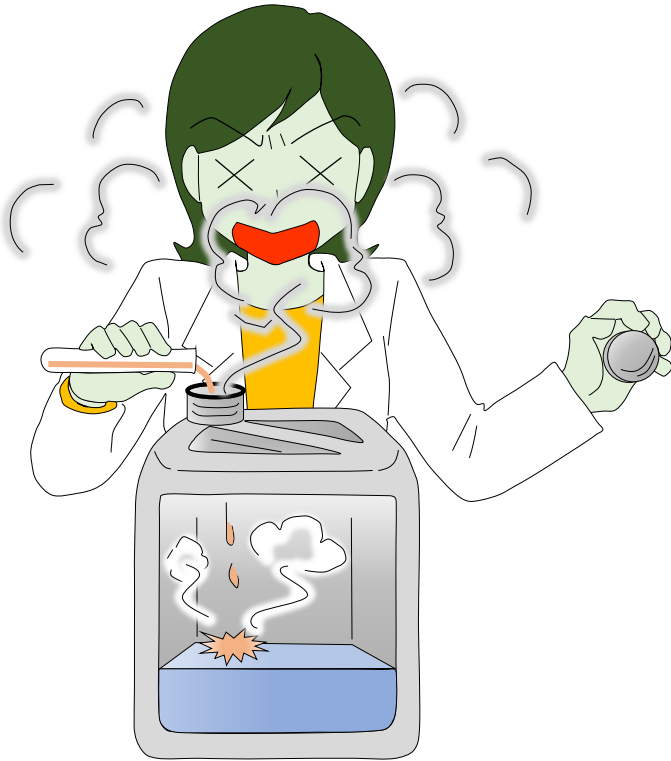
Waste liquid tank used as part of perfume research procedure

As part of a perfume research procedure, the victim poured waste phosphoryl chloride reagent into a waste liquid tank filled with water to prevent fires. The waste liquid reacted with the water in the tank, generating chlorine gas, to which the victim was exposed.

The victim was transported to the hospital by ambulance, diagnosed with chlorine gas poisoning and chemical conjunctivitis, and hospitalized.

[4] A risk assessment must be performed following any changes in waste liquid tank procedures. Any change must include health and safety training. Accident prevention measures must be implemented to ensure workers are aware of hazards and toxicity.

We recommend deploying gas monitoring systems and implementing measures to minimize the risks associated with working in environments in which gas may be generated, as highlighted in risk assessments.
