Case involving chlorine gas generated during cleaning work in vegetable washing room

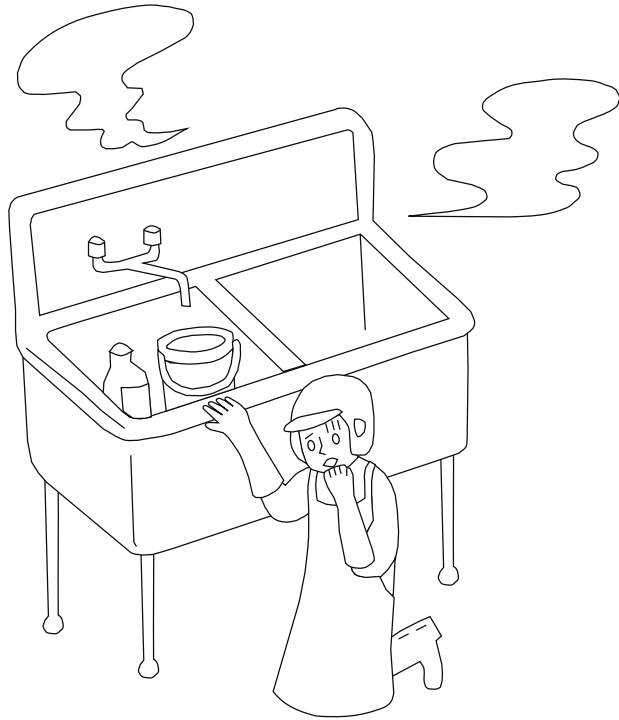
Sterilizing water generating system in vegetable washing room

Sodium hypochlorite was taken from a container in the sterilizing water generating system and used to remove mold from the wall of the washing room and equipment. A worker accidentally poured the remaining sodium hypochlorite into an adjacent container of hydrochloric acid when attempting return it to its container, generating chlorine gas.

While no workers reported feeling ill during the subsequent evacuation or while the gas was being treated, a worker began to feel unwell after returning home and was transported to the hospital by ambulance.

[4] Perform risk assessments and implement adequate measures to minimize risks.

We recommend deploying gas monitoring systems and implementing measures to minimize the risks associated with working in environments in which gas may be generated, as highlighted in risk assessments.
